CARR ENGINEERING, INC.

RE: Manley v. FCA US, LLC

Pursuant to your request, I have reviewed information related to the Manley v. FCA case, which involves a February 16, 2017, alleged unintended acceleration of a 2011 Jeep Grand Cherokee with VIN 1J4RR6GT9BC620745 ("subject vehicle"). I have been asked to determine if the engine control electronics, including electronic throttle control ("ETC") and other related components and systems on the subject vehicle performed as designed prior to and during the incident. To evaluate the facts and circumstances surrounding this incident and to support my conclusions, I have inspected and tested the subject vehicle, reviewed photographs and test results from an exemplar vehicle, analyzed engineering and service documents, reviewed crash scene photographs, police and fire reports, vehicle records, and other relevant materials. I have applied scientific methodology and electrical engineering principles in my analysis. Appendix 1 contains a list of materials I have reviewed.

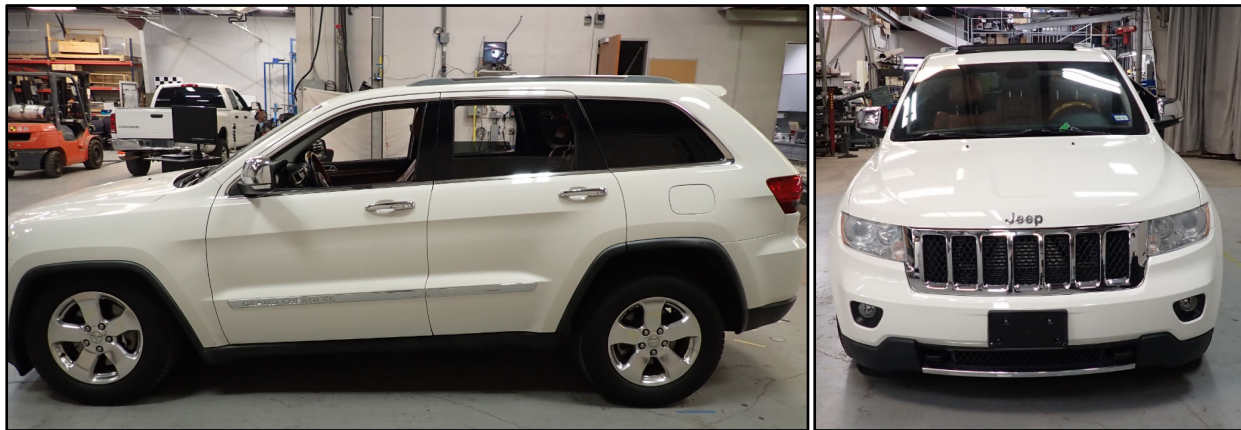
An exemplar vehicle inspection was performed at BRC, in San Antonio, Texas. The vehicle inspected was a 2011 Jeep Grand Cherokee, equipped with the 5.7L V8 ETC system, with VIN 1J4RR6GT5BC727288. The Carfax report for this vehicle shows that the service-related work performed has been standard scheduled maintenance. There is one incomplete recall for a fuel pump relay failure, which in some cases can cause a stall condition if the vehicle is running or a no-start condition if not running. Figure 3 shows photographs of the exemplar vehicle.

Figure 3 – Photographs of the exemplar vehicle evaluated for comparison to the subject vehicle.
(P3221276.JPG and P3221275.JPG)

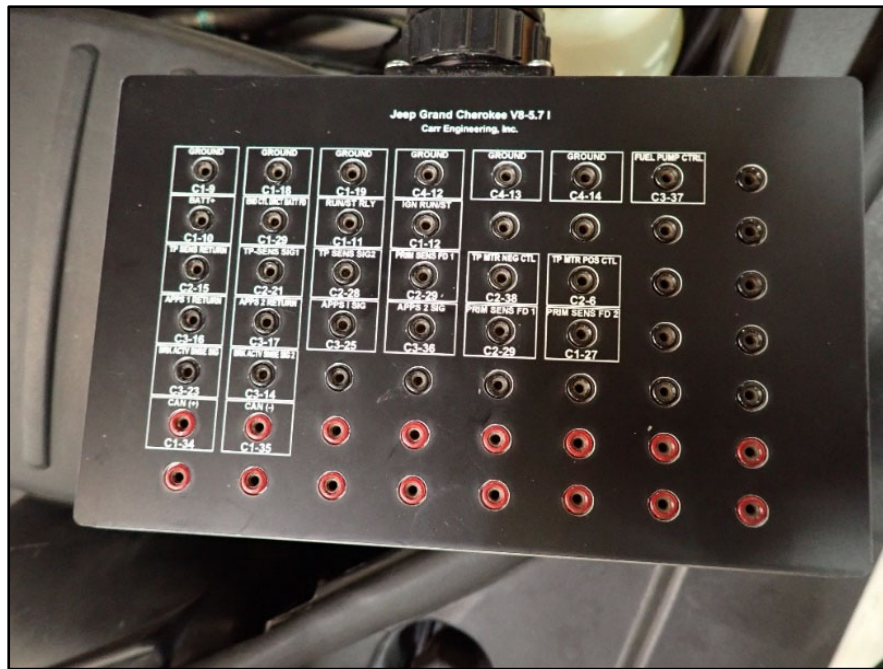
As with the subject vehicle inspection and testing, the exemplar vehicle analysis utilized a breakout box⁴ to test the integrity of the electrical connections between the PCM and relevant ETC circuits and components. These circuits and components include: power and ground, accelerator pedal position sensors, throttle position sensors, throttle valve motor, and the brake/stop lamp switch.

Figure 4 – Photograph of the breakout box used to perform electrical measurements. (P3231305.JPG)
